## Machinery Messages

### Case History

# Remote diagnosis of a pure *Half X* vibration problem in a power plant

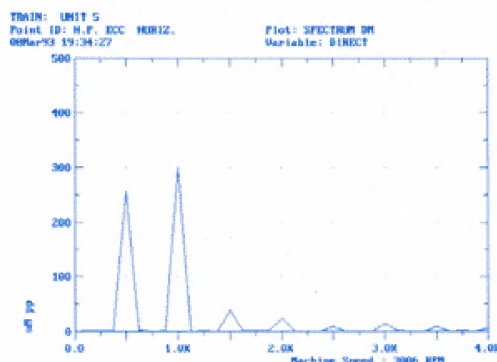
In March 1993, the machine was shut down over a weekend. No work was performed on the turbine, but on the subsequent startup, vibration levels fluctuated. The horizontal vibration level reached  $430\text{ }\mu\text{m}$  (17 mils), with a 1X component of  $300\text{ }\mu\text{m}$  (12 mils) and a component at exactly 0.5X running speed of  $260\text{ }\mu\text{m}$  (10.2 mils). (Note: individual vibration components do not sum arithmetically to give the overall value.)

Figure 2  
Spectrum plot, showing high vibration levels on the No.1 bearing.

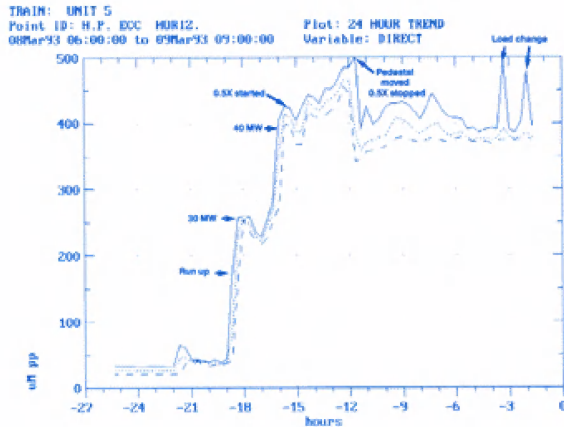
Upon startup, the same problems occurred, and additional plots were faxed to MDS. The direct (overall) 24-hour vibration trend plot (Figure 3) shows how the vibration levels varied. The three lines (solid, dotted and dashed) on the plot show maximum, average and minimum values, respectively. At a 30 MW load, there was no 0.5X vibration present, and the overall vibration level was  $270\text{ }\mu\text{m}$  (10.6 mils). The 1X vibration component increased with increasing load, and at 40 MW, the 0.5X component appeared, at a level of  $260\text{ }\mu\text{m}$  (10.2 mils). The 1X vibration component had increased to  $400\text{ }\mu\text{m}$  ▶

(15.7 mils). The two components combined to give overall levels of 450 to 500  $\mu\text{m}$  (18 to 19.7 mils).

**Figure 3**  
24-hour trend plot of the No.1 bearing overall vibration as load was applied.

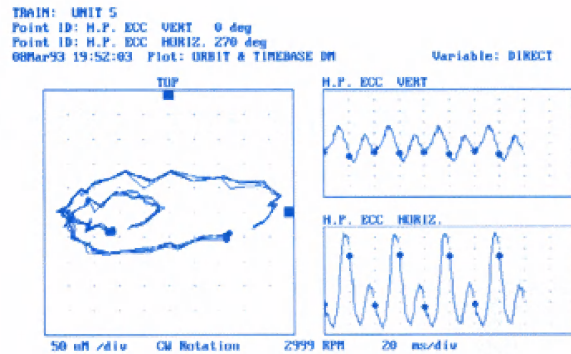
The 0.5X component remained until further temperature changes occurred. The pedestal moved again, and the 0.5X component disappeared. The vibration decreased to approximately 400  $\mu\text{m}$  (15.7 mils). The turbine ran at this vibration level until it was shut down due to a boiler tube leak. Figure 4 shows the unfiltered orbit and waveforms when the 0.5X component was present.

rotor-to-casing radial rub, as the HP casing became distorted when the HP pedestal stuck on its slides. The orbit's shape indicated that the rub was occurring at the left-hand side of the casing, at the nine o'clock position, as viewed from the driver end of the machine.

**Figure 4**  
Unfiltered orbit and timebase plot when the 0.5X vibration component was present.

The top half HP casing steam glands at the No. 1 bearing end were removed and indications of a rub were seen at the nine o'clock position, as had been predicted from the unfiltered orbit plot.

The No. 1 bearing was moved 0.25mm (10 mils) to the right to increase the clearance between the shaft and the left-hand side of the casing.

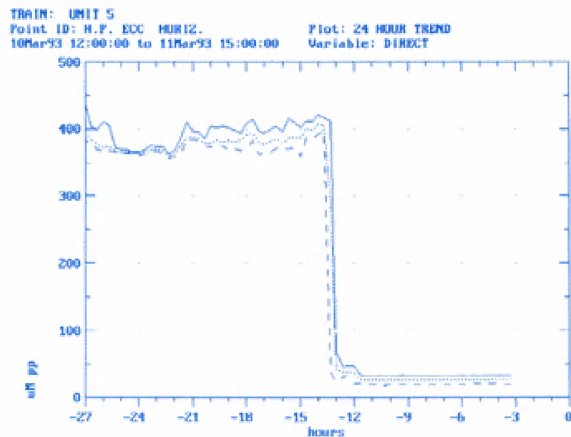
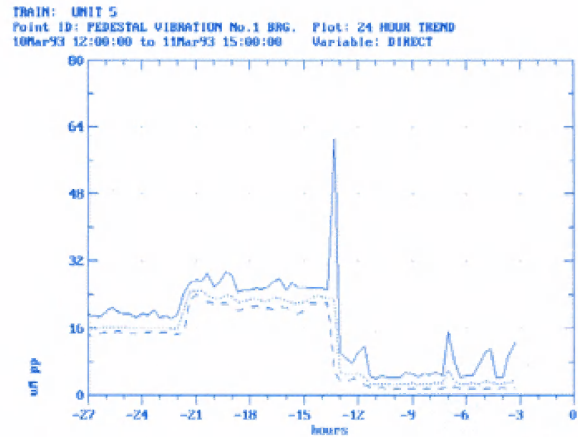
Figures 5 and 6 show the HP horizontal vibration and pedestal overall vibration trends from the time the 0.5X vibration disappeared until the machine was shut down.

At approximately 3:00 PM on March 10, the average vibration reading at the No. 1 bearing was approximately 370  $\mu\text{m}$  (14.6 mils), while the pedestal vibration level was 16  $\mu\text{m}$  (0.63 mils), a shaft to pedestal displacement ratio of 23 to 1. As it is well-known that this type of bearing pedestal does not have a high mechanical impedance, this ratio was considered to be high. Therefore, it was concluded that only low levels of force were transmitted through the bearing oil film to the pedestal, in spite of the large amplitude of the shaft motion.

It is also noteworthy that the force transmitted to the pedestal increased disproportionately as more of the bearing clearance was taken up by the shaft motion. At 6:00 PM, vibration at the bearing had increased to 390  $\mu\text{m}$  (15.4 mils), a 5.5% increase. However, the pedestal vibration had increased to 24  $\mu\text{m}$  (0.94 mils), a 44% increase. Based on the available information, MDS concluded that the No. 1 bearing was misaligned and was low, partly as a result of settling. Therefore, the bearing was not providing adequate support for the HP shaft.

**Figures 5 & 6**  
Shaft and pedestal 24-hour trend plots from when the 0.5X vibration component disappeared to shutdown.

In a phone conversation with the plant engineer, MDS discussed their conclusions regarding both the rub and the No. 1 bearing alignment. The engineer checked the original alignment catenary figures, which confirmed that the No. 1 bearing had been low following the overhaul. During a shutdown over the following weekend, the HP pedestal was raised by 0.5 mm (20 mils). Since the HP casing is attached to the pedestal, the move didn't affect internal alignment between the shaft and the HP casing.

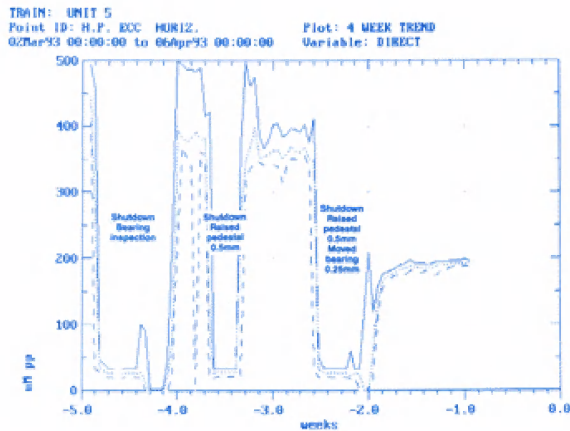
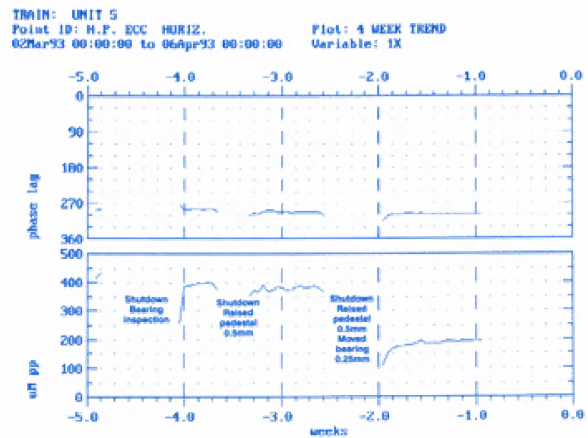
When the turbine was restarted, the rub still occurred for part of the running time, but the underlying 1X vibration level was approximately 20  $\mu\text{m}$  (0.8 mils) lower as a result of the pedestal move (Figures 7 and 8).

Following the moves, the turbine ran with overall and 1X vibration levels of 200  $\mu\text{m}$  (7.9 mils) (Figures 7 & 8). The HP pedestal horizontal vibration level was 25  $\mu\text{m}$  (1 mil). No subsynchronous vibration occurred, and the load could be varied as required without causing significant vibration changes. The vertical alignment change reduced the high 1X vibration and the horizontal bearing movement eliminated the 0.5X component. The problems were resolved without sending a vibration specialist to the plant. The on-line data captured and plotted by the TDM System enabled MDS engineers to diagnose the problem from a remote location. ■

**Figures 7 & 8**  
4-week overall and 1X trend plots, showing lower vibration levels after the change.

The HP pedestal was raised 0.5mm (20 mils) more to provide additional load to the bearing.
